**Eastern Star/Santos Narrabri Coal Seam Gas Exploration Project, Dewhurst sites.**

**Pictures taken 1<sup>st</sup> January, 2010 after seasonal rains (a 'normal' rain event).**

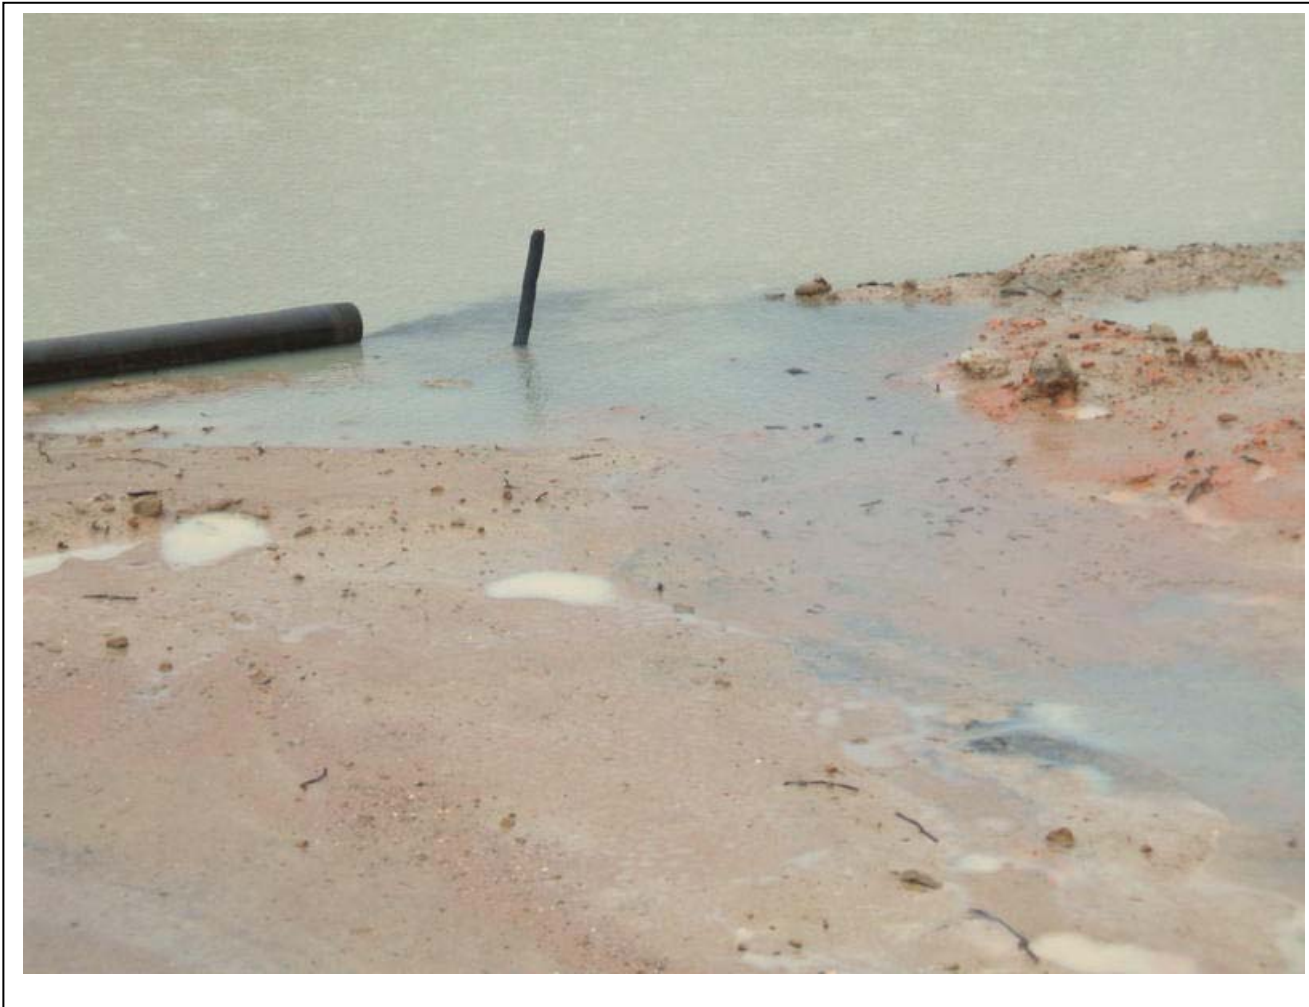
**Picture 1. Environmental damage caused by poor construction of gas exploration drilling ponds after rain at site Dewhurst 17.**

**Note contaminated water overflowing from the sump pond.**

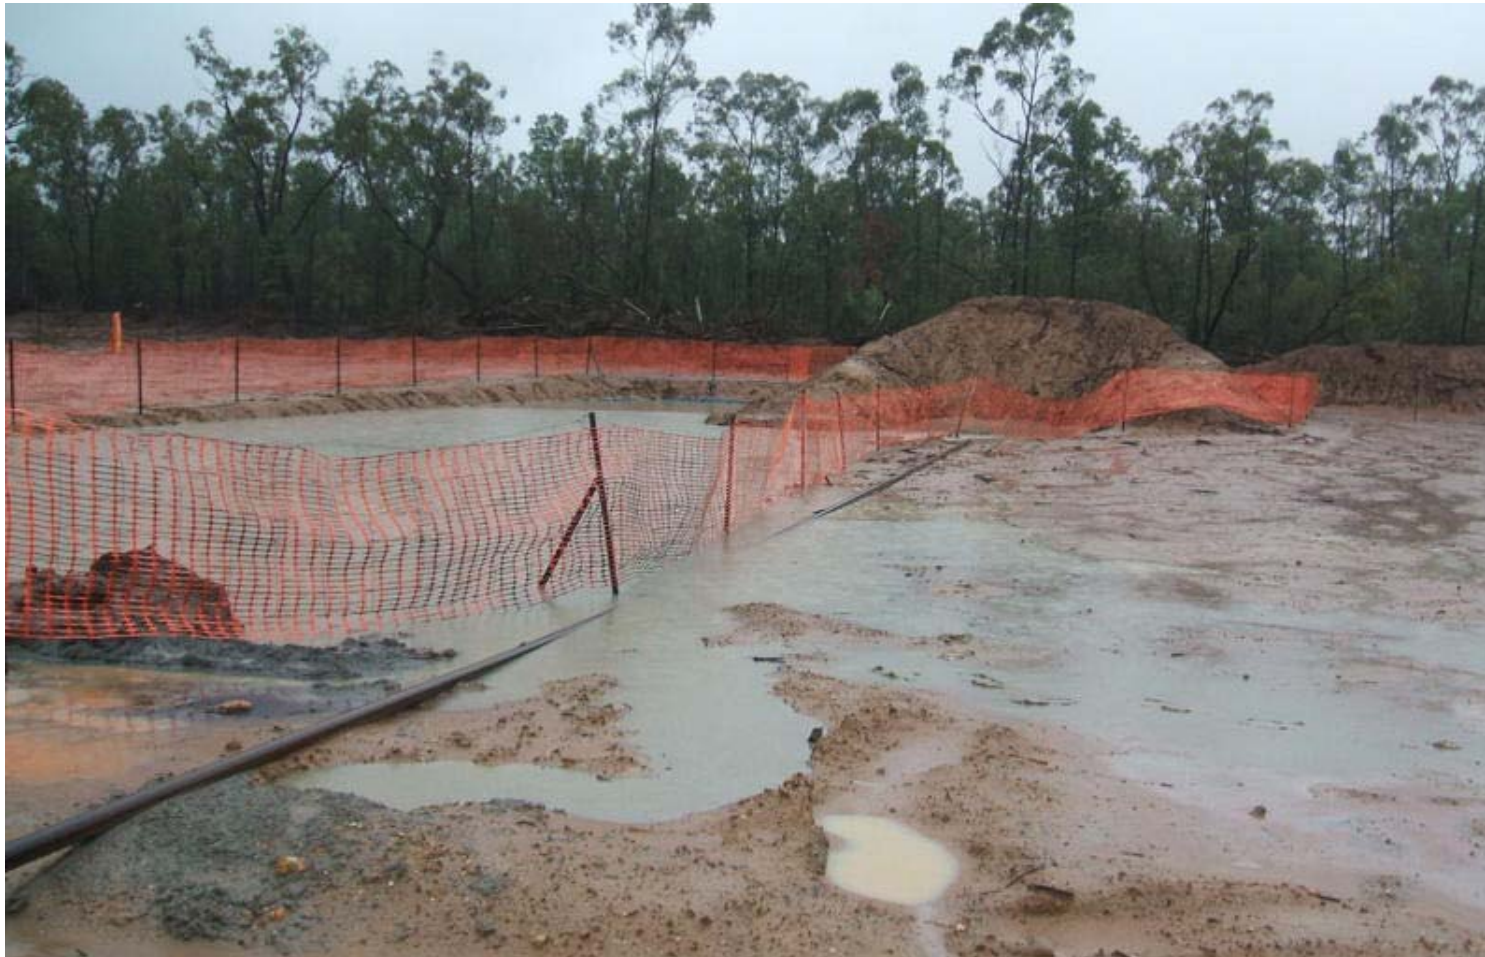
**Picture 2. Site Dewhurst 16H. Sump pond overflowing. Note also the waste from the well head also contaminating and leaking over the site and ultimately into the East Pilliga State Forest.**

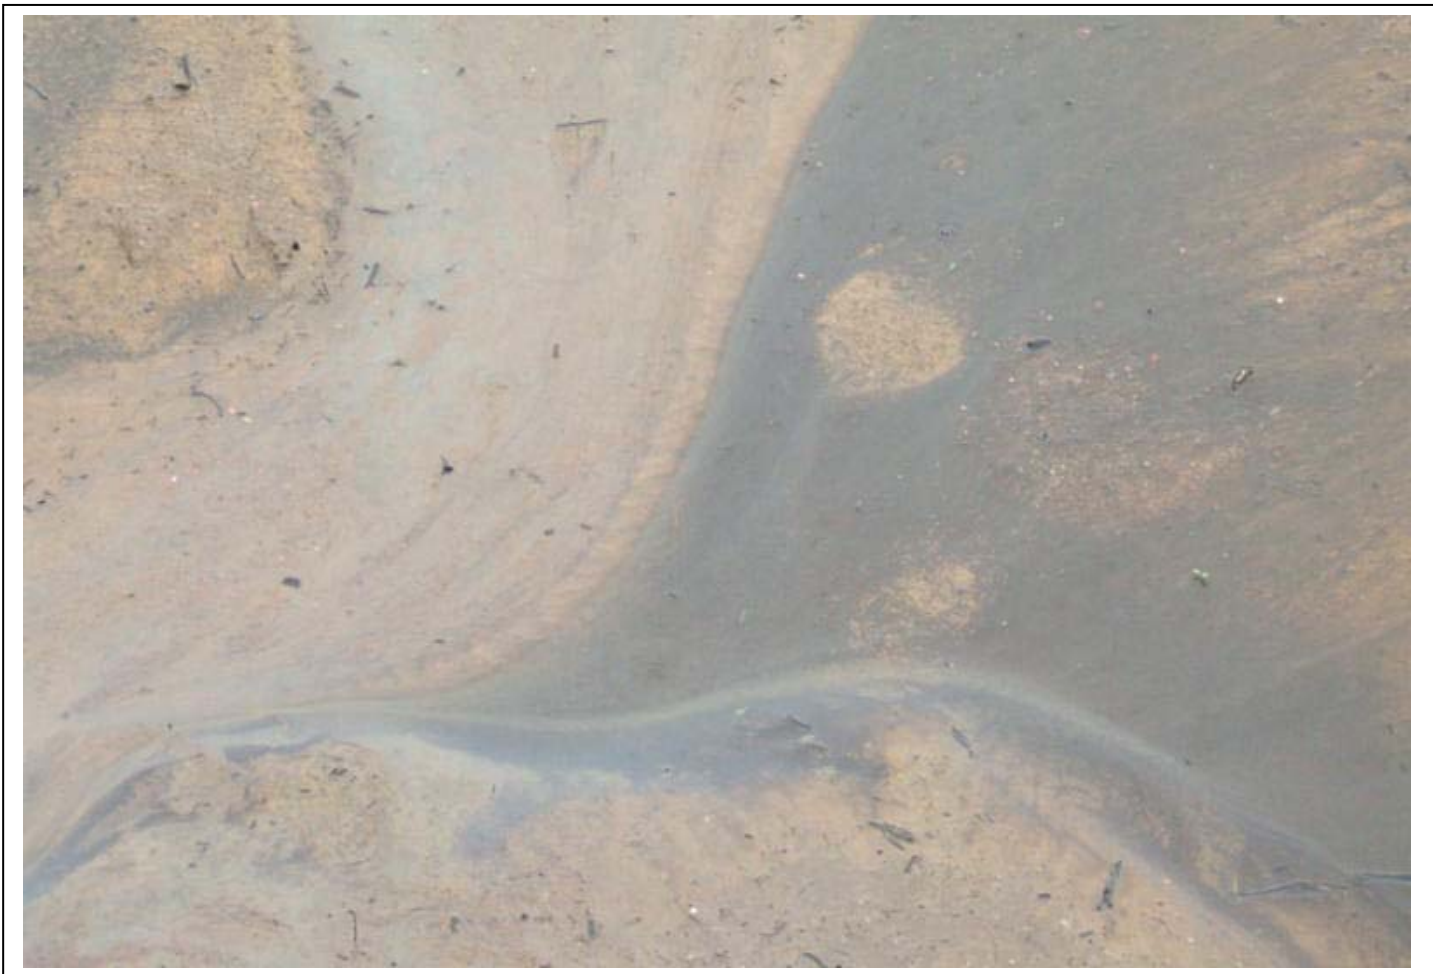
**Picture 3. Site Dewhurst 17. Unknown material escaping from pit including waste drilling fluids and tailings from the bore hole.**

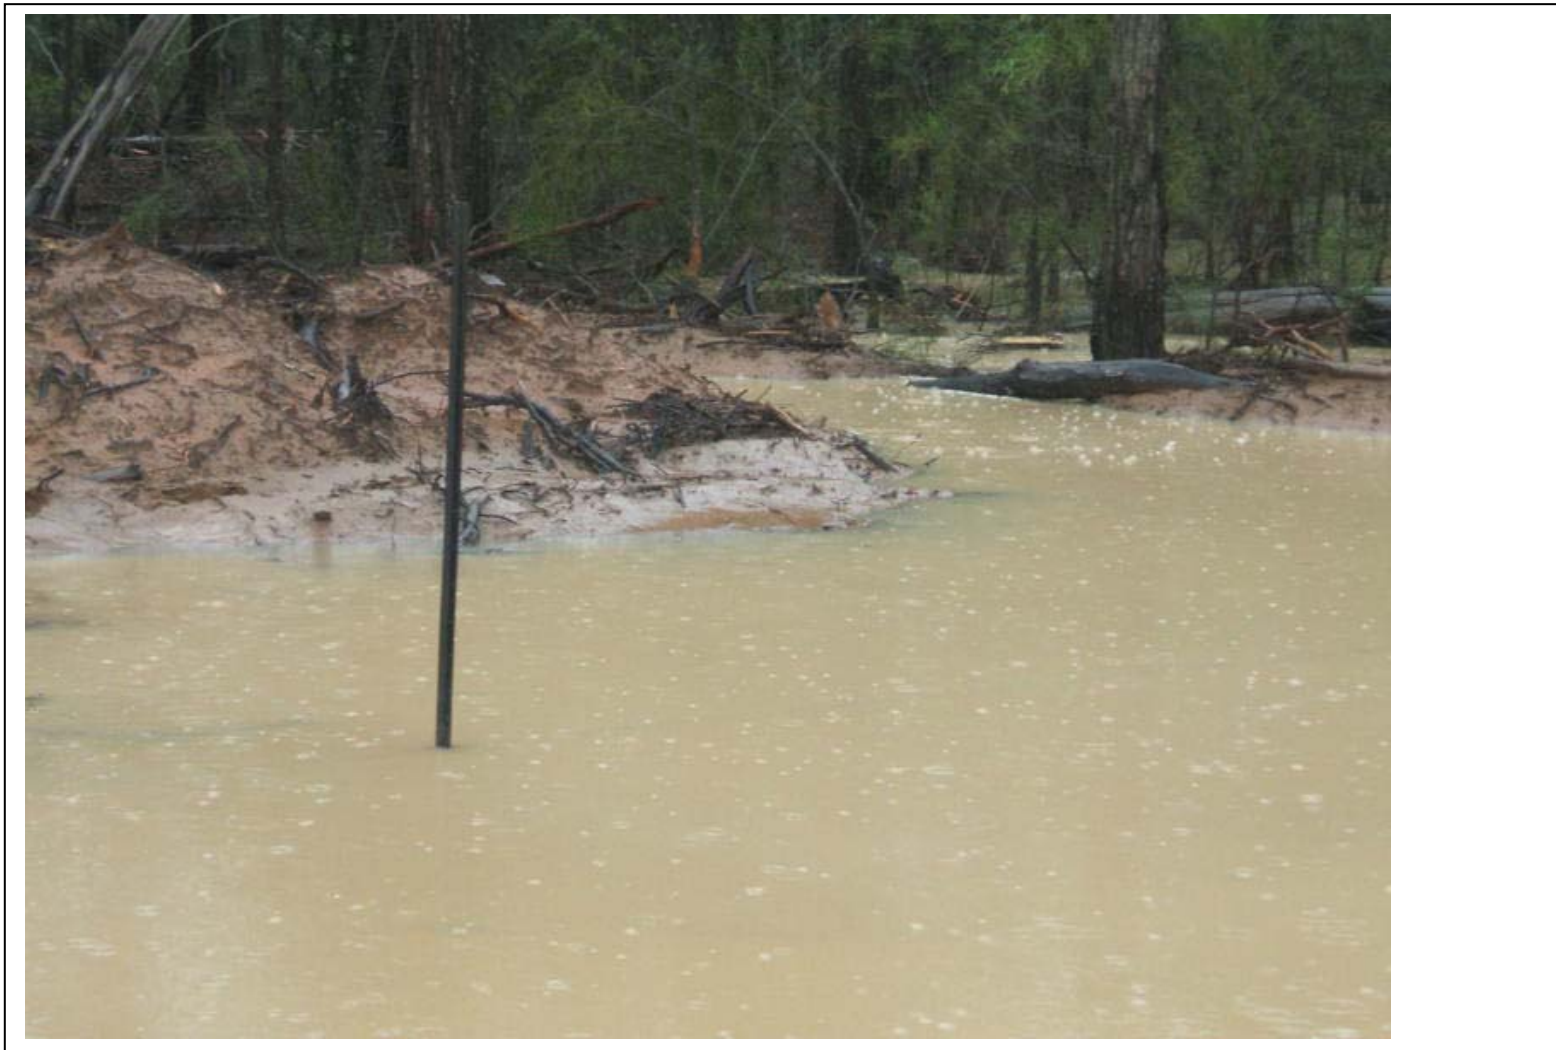
**Picture 4. Site Dewhurst 16H. Contaminated water escaping into the East Pilliga State Forest. This water linked up with water from the overflow at Dewhurst 17H. Water from here runs into Jacks Creek and ultimately into the Namoi Catchment which feeds into the Murray-Darling Basin.**

**Note also that this site is unfenced – only steel posts with one very low wire was put around this site to protect native animals – inappropriate containment for what is really an industrial site.**

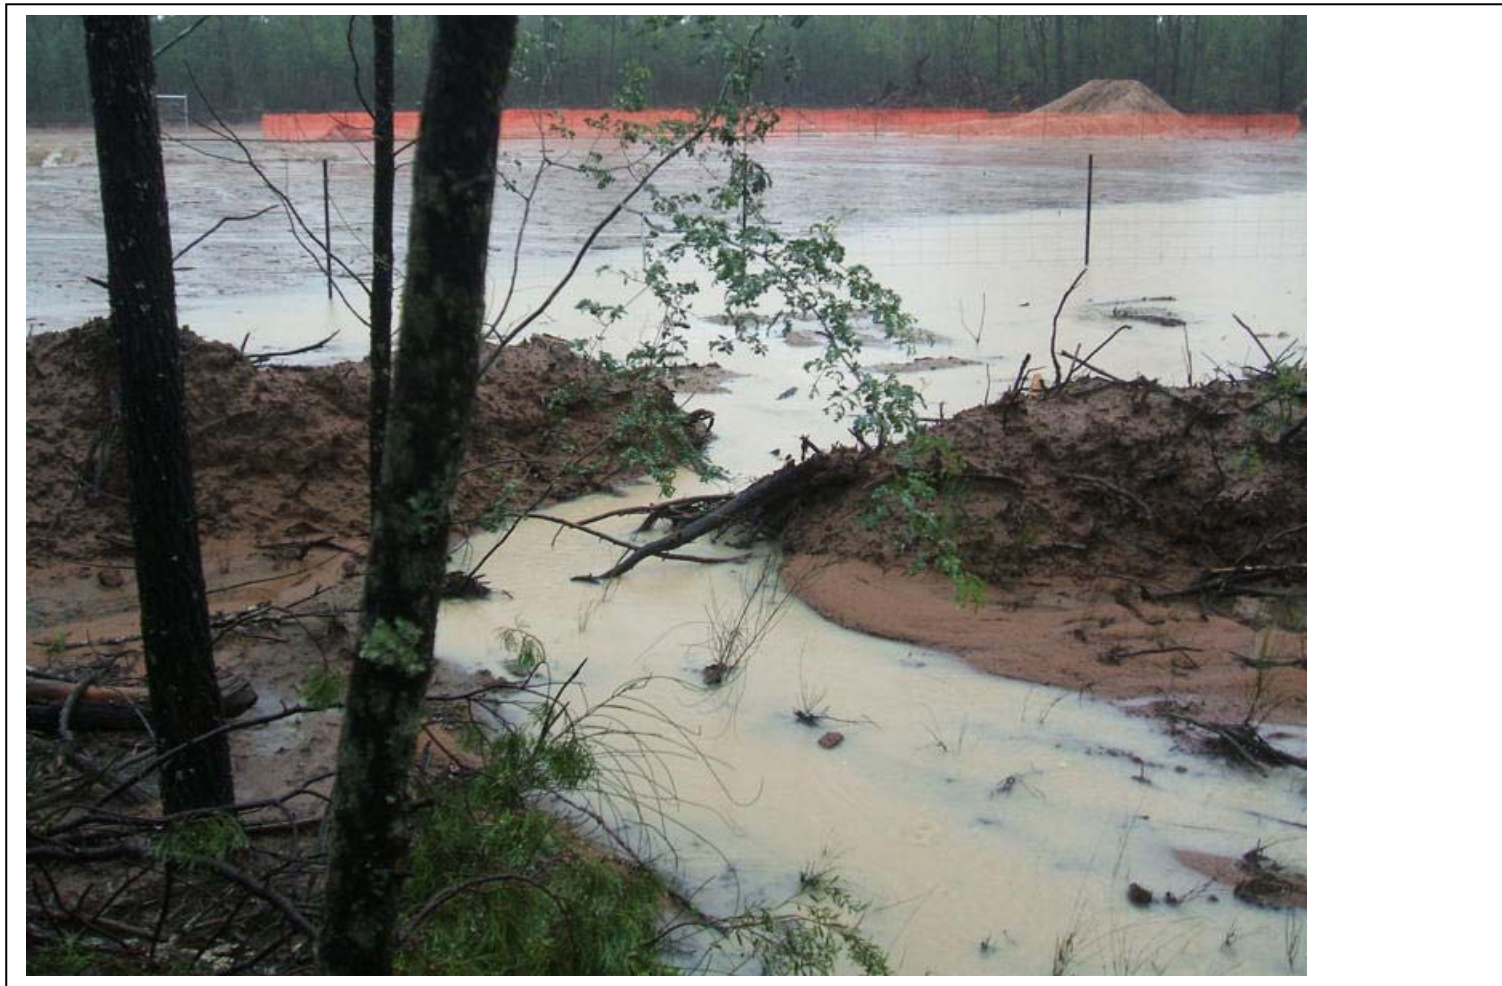
**Picture 5. Site Dewhurst 17H. Accumulated water from pits overflowing into the East Pilliga State Forest.**

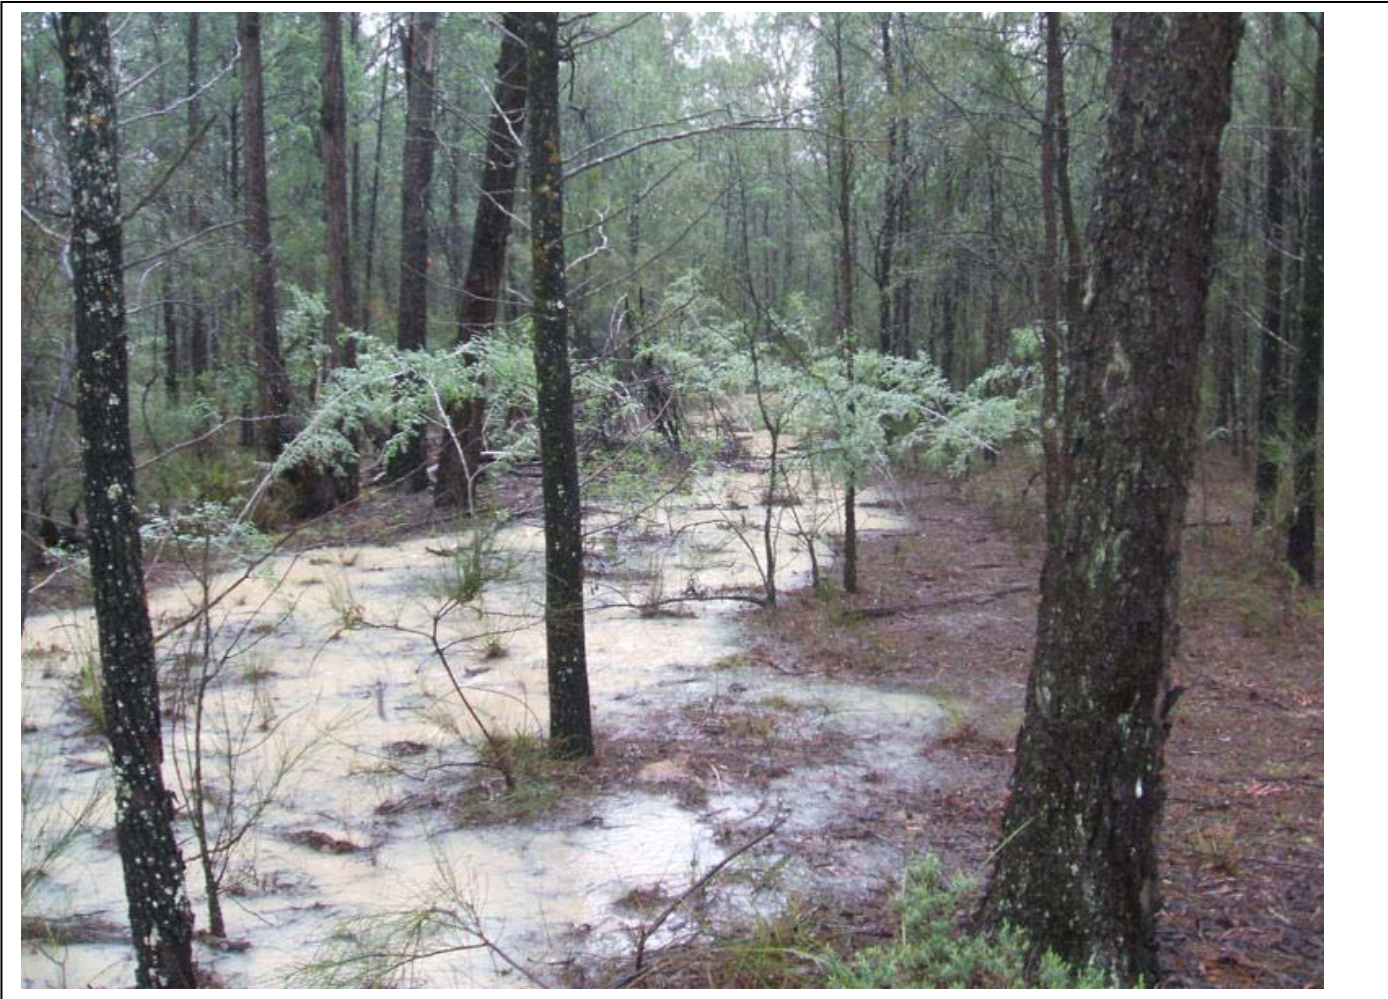
**Picture 6. Contaminated water from both Dewhurst 16H and 17H sites flowing down to Jacks Creek and thence into the Namoi Catchment and into the Murray Darling Basin.**
