Report on the investigation of
the loss of the yacht
Cheeki Rafiki
and its four crew
in the Atlantic Ocean,
approximately 720 miles east-south-east of
Nova Scotia, Canada
on 16 May 2014

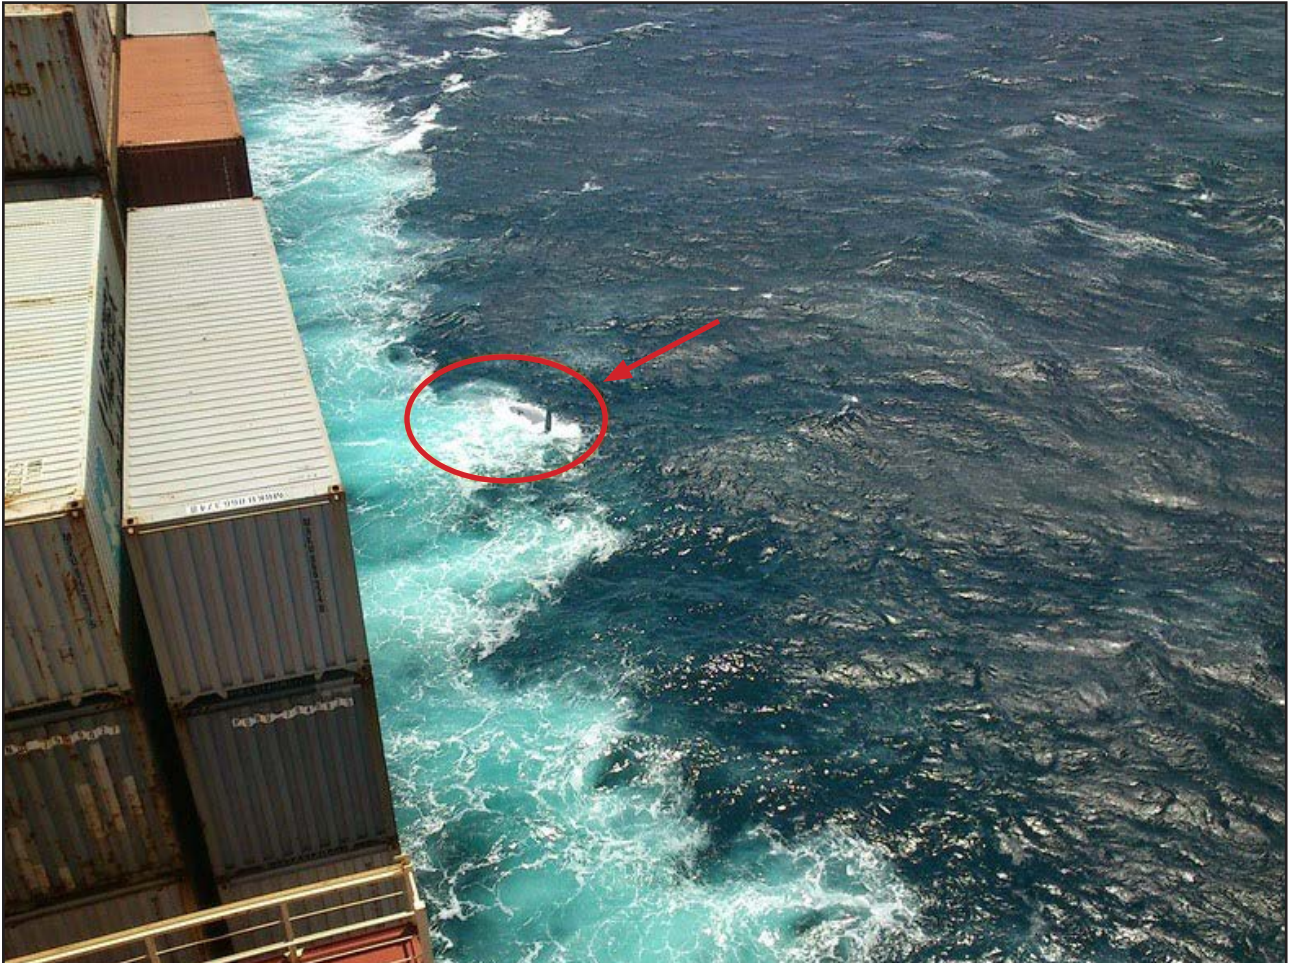
At about 1400 on 17 May 2014, the container ship *Maersk Kure* located the upturned hull of a small boat, which was believed to be *Cheeki Rafiki*. Adverse weather conditions prevented launching the ship's lifeboat or rescue boat (**Figure 6**) to carry out a closer inspection.

Figure 6: Photograph showing the upturned hull of a small boat alongside the container vessel *Maersk Kure* taken on 17 May 2014 at about 1400

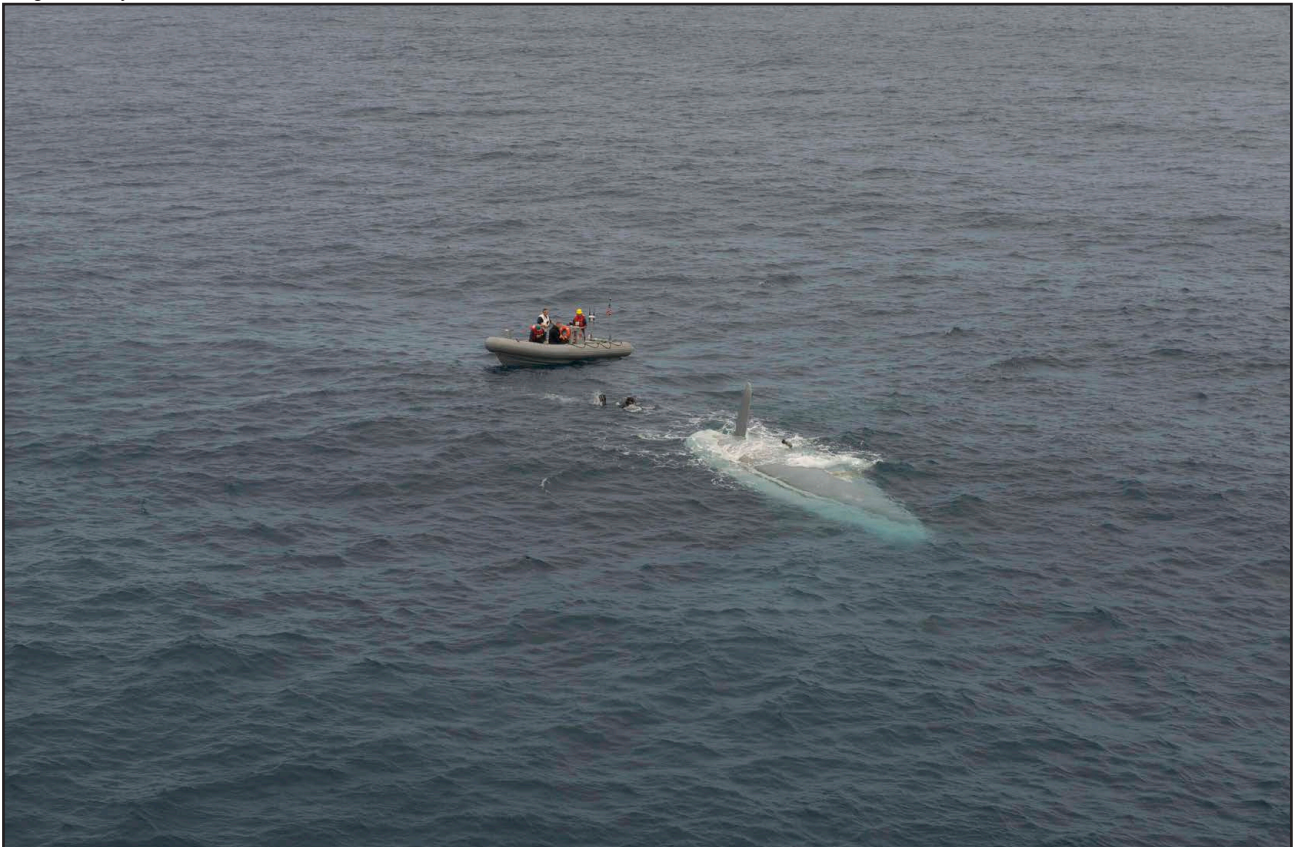
Figure 7: Photograph of *Cheeki Rafiki*'s upturned hull being inspected by the US Navy

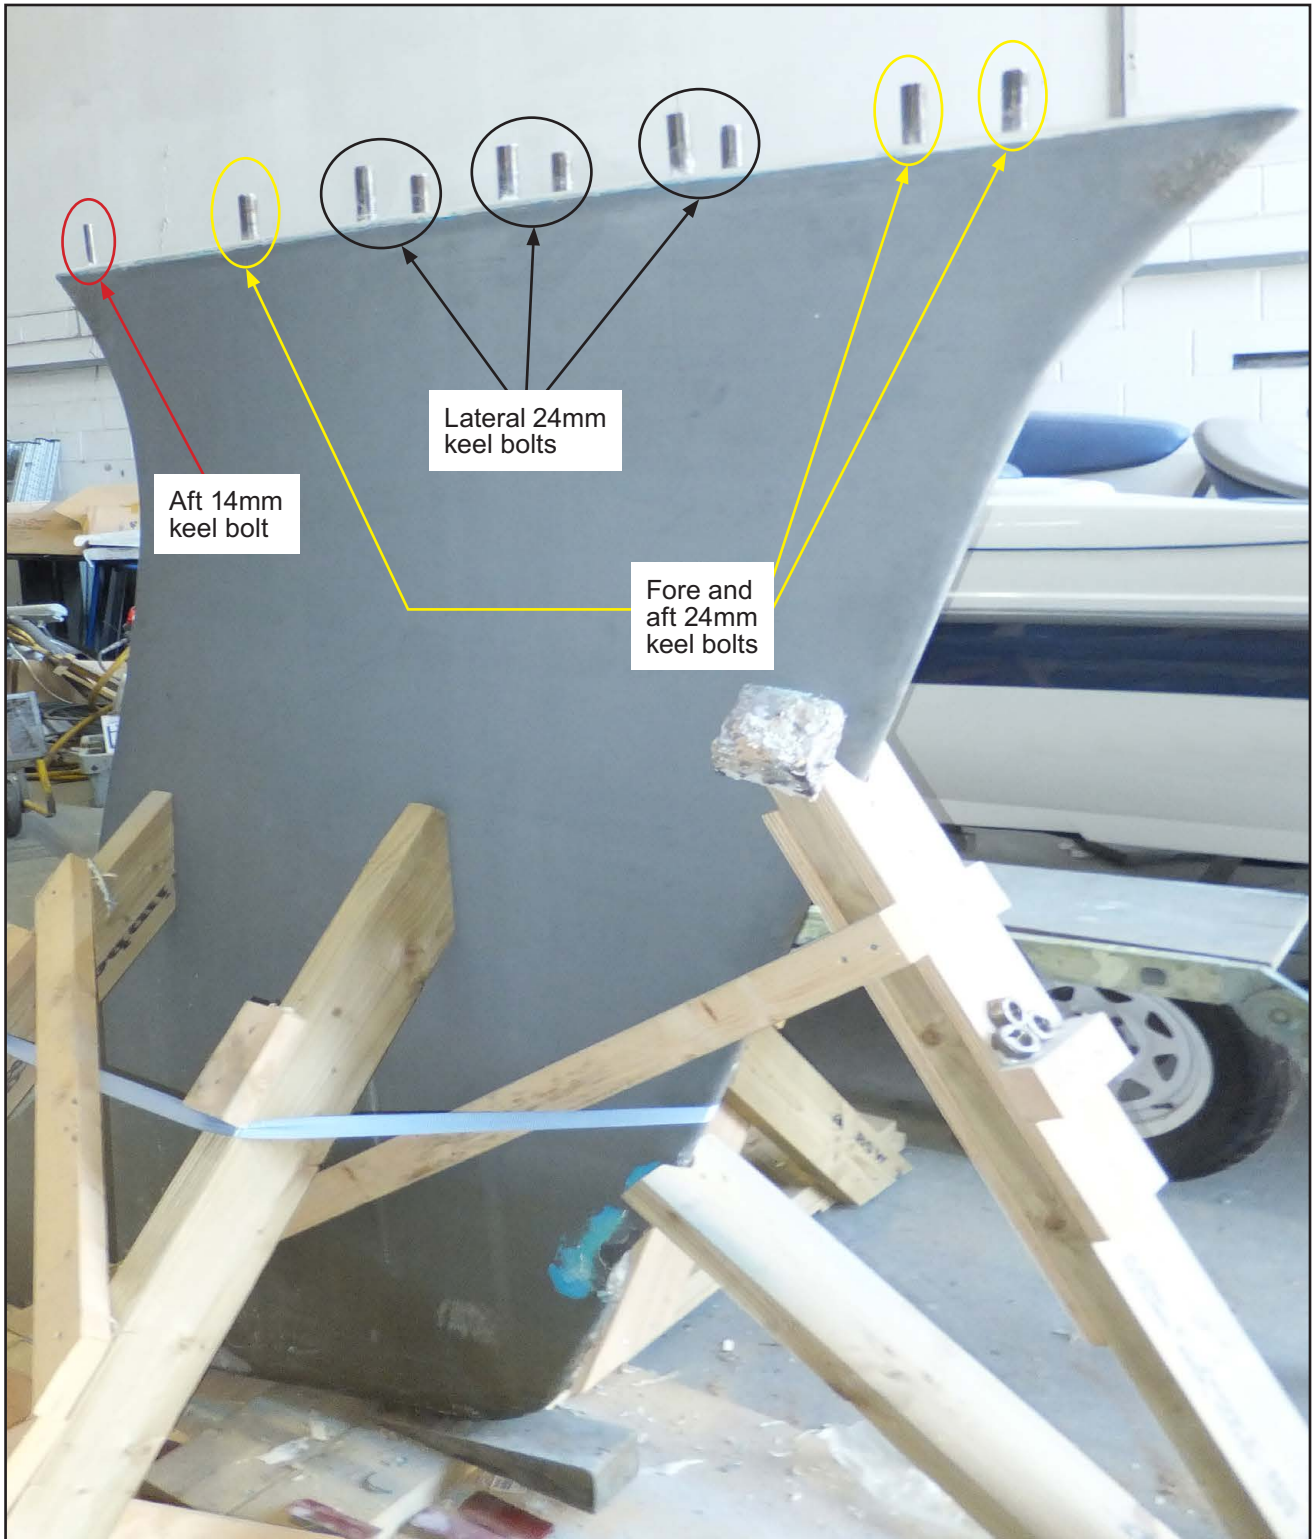
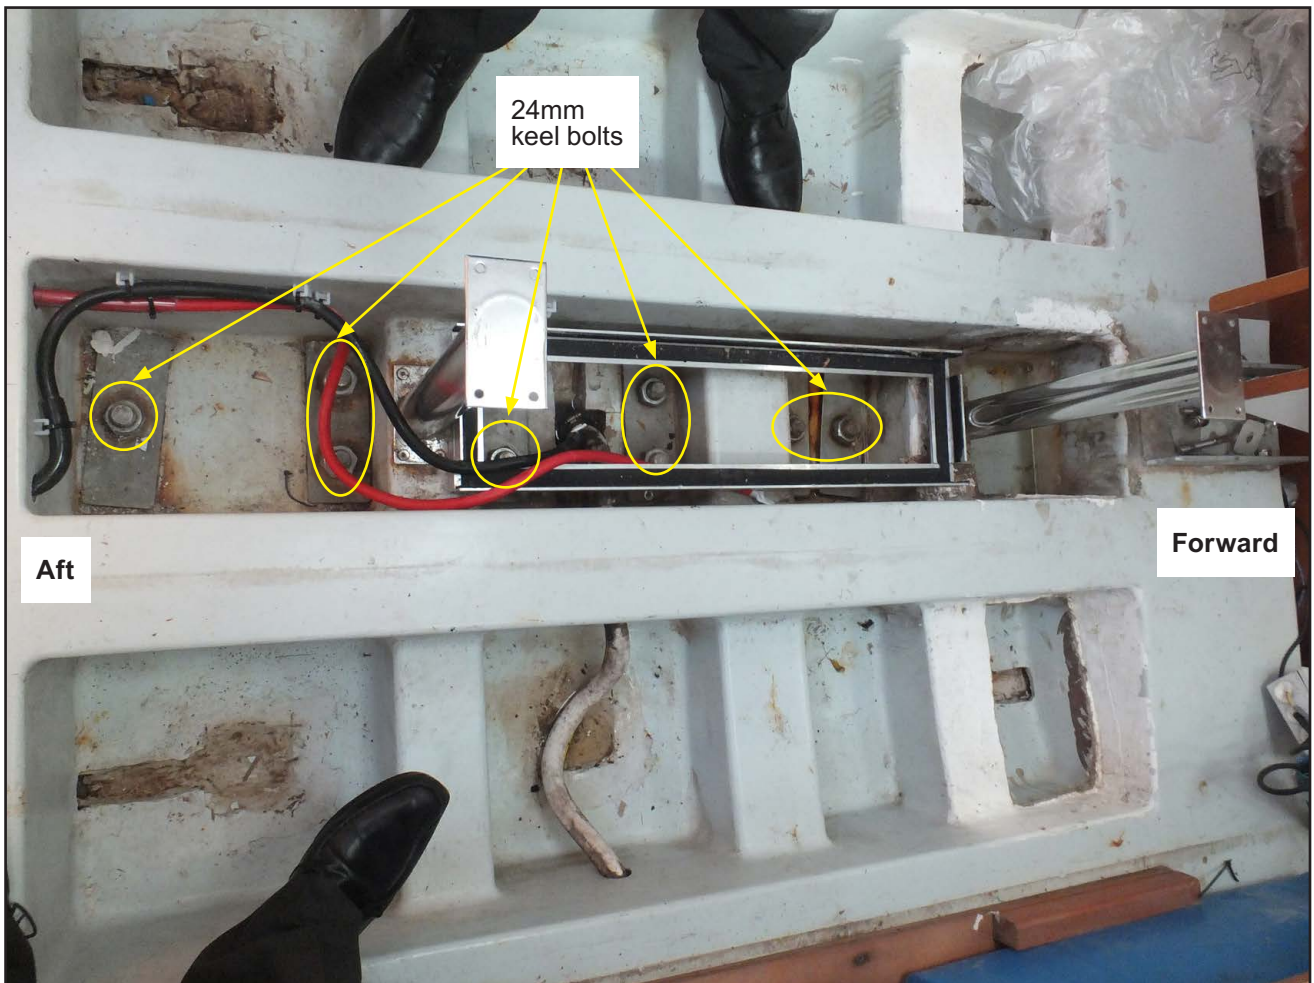
The Beneteau First 40.7 was available with two keel options: a shorter cast iron bulb type keel and a more popular deep fin cast lead keel. The lead keel was manufactured with stainless steel bolts cast into it. There were nine 24mm bolts: three designed to carry the fore and aft loading on the keel, and six primarily to carry the lateral loading (**Figure 9**). The three bolts carrying the fore and aft loading were arranged with two single bolts at the forward end of the keel and one single bolt aft. The six bolts designed to carry the lateral loading were arranged in pairs. All of the 24mm bolts were secured to the glass reinforced plastic (GRP) hull with a washer (i.e. backing) plate and nut (**Figure 10**).

Figure 9: Typical Beneteau First 40.7 keel bolt arrangement (not *Cheeki Rafiki*)

Figure 10: Typical Beneteau First 40.7 keel bolt arrangement (not *Cheeki Rafiki*)

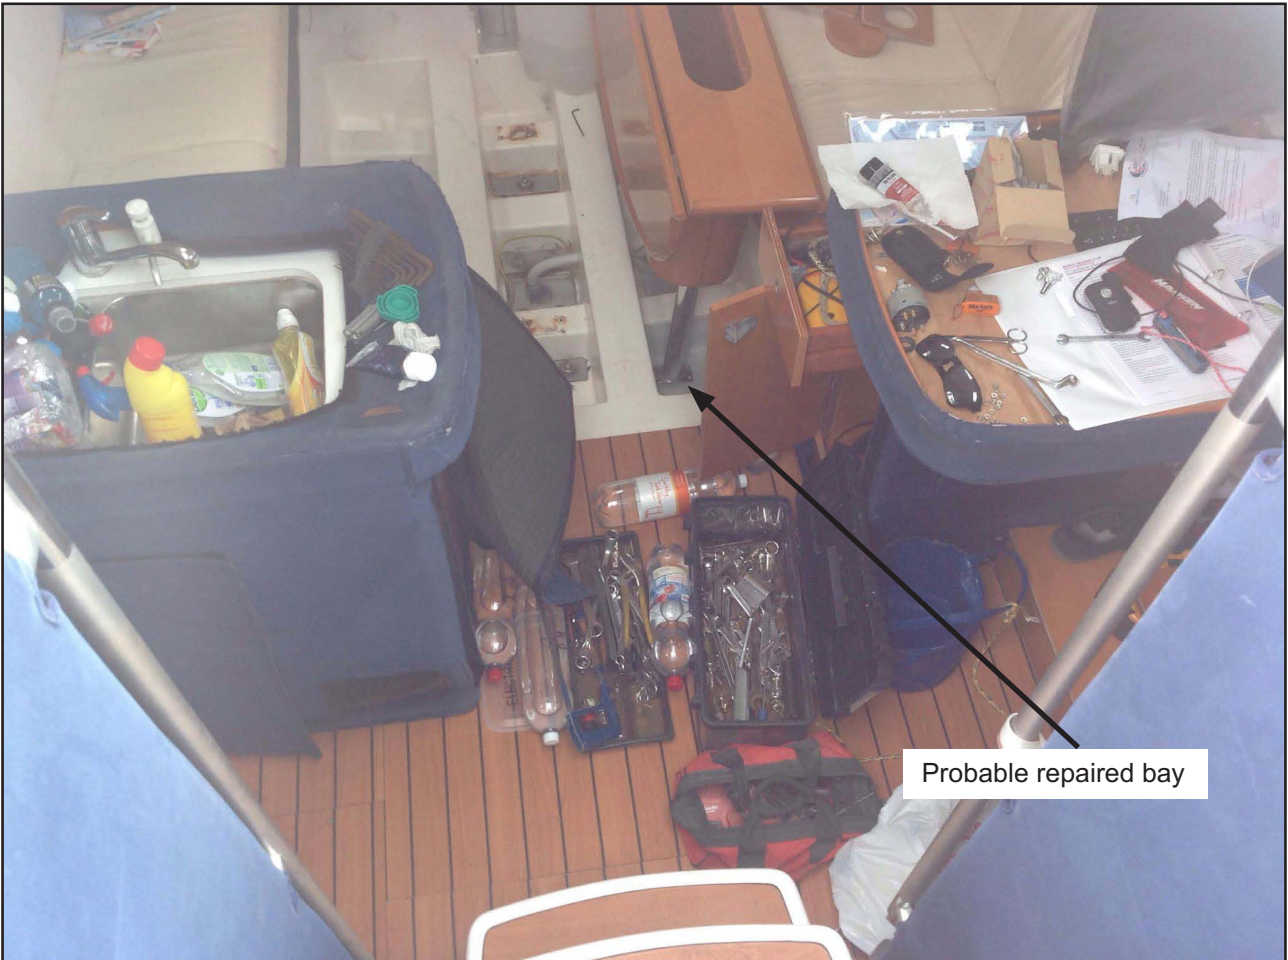
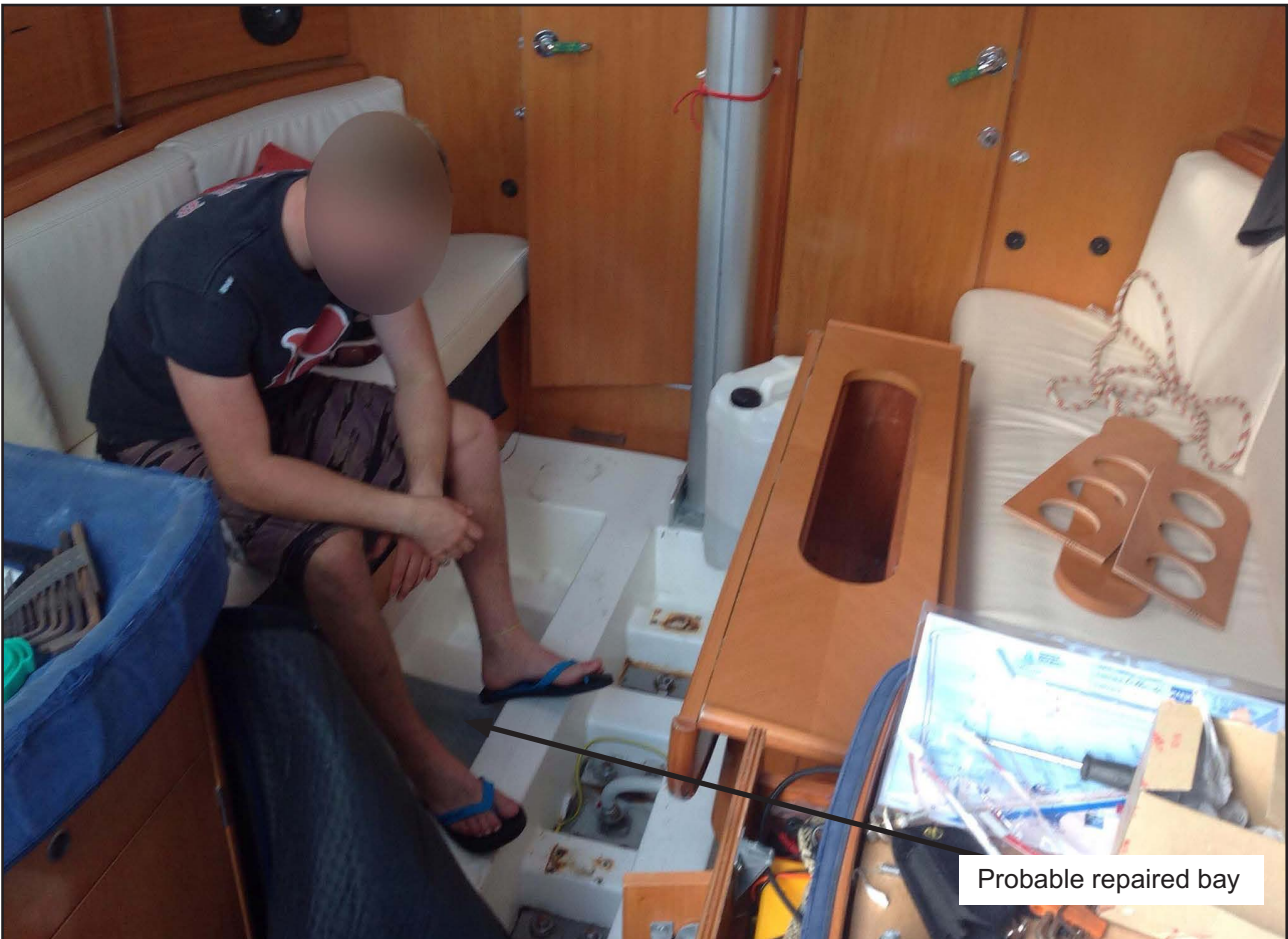
Figure 16: *Cheeki Rafiki's* keel bilge area prior to departure on the ARC 2013, with table temporarily removed

Figure 17: *Cheeki Rafiki's* keel bilge area prior to departure on the ARC 2013, with table temporarily removed

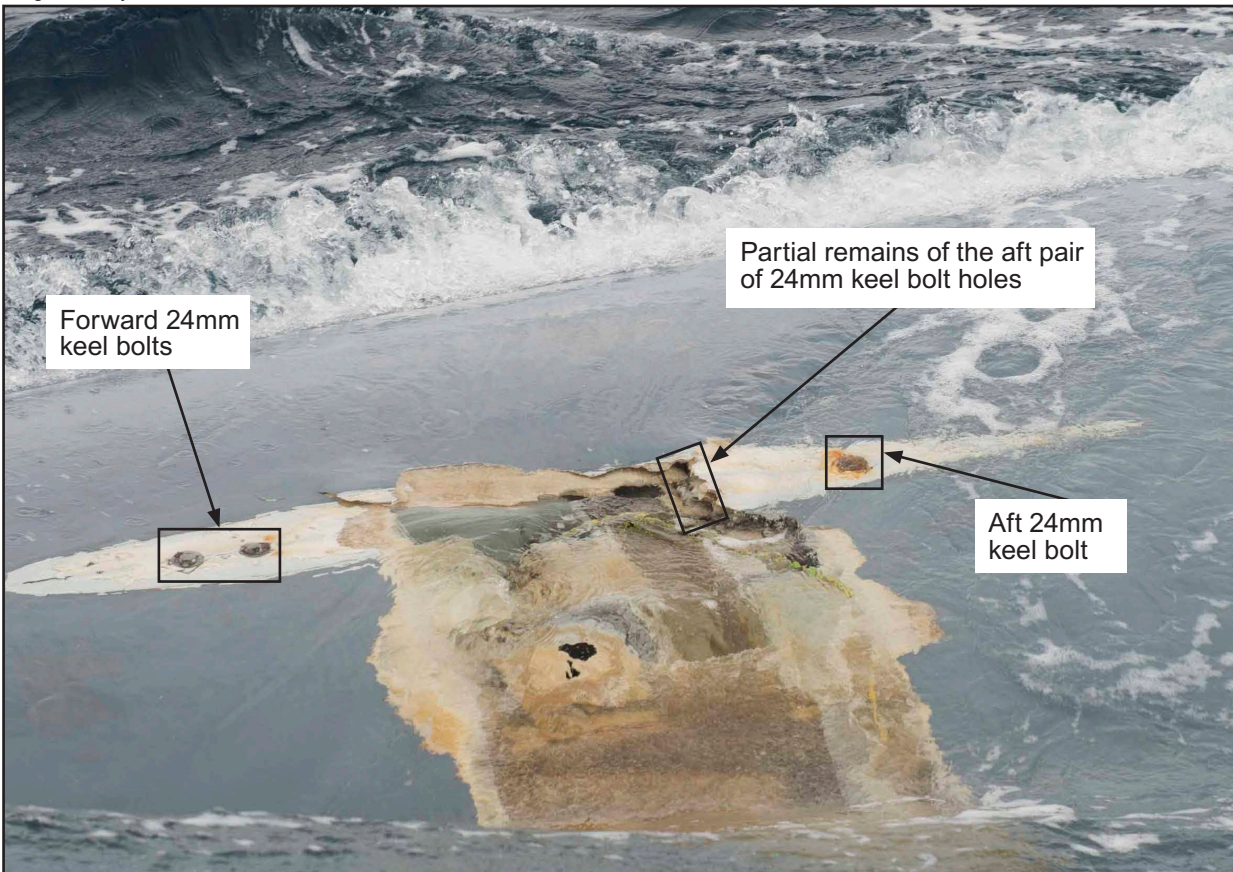
Figure 18: Photograph of *Cheeki Rafiki's* upturned hull taken by the crew of USS *Oscar Austin* in the afternoon of 23 May 2014

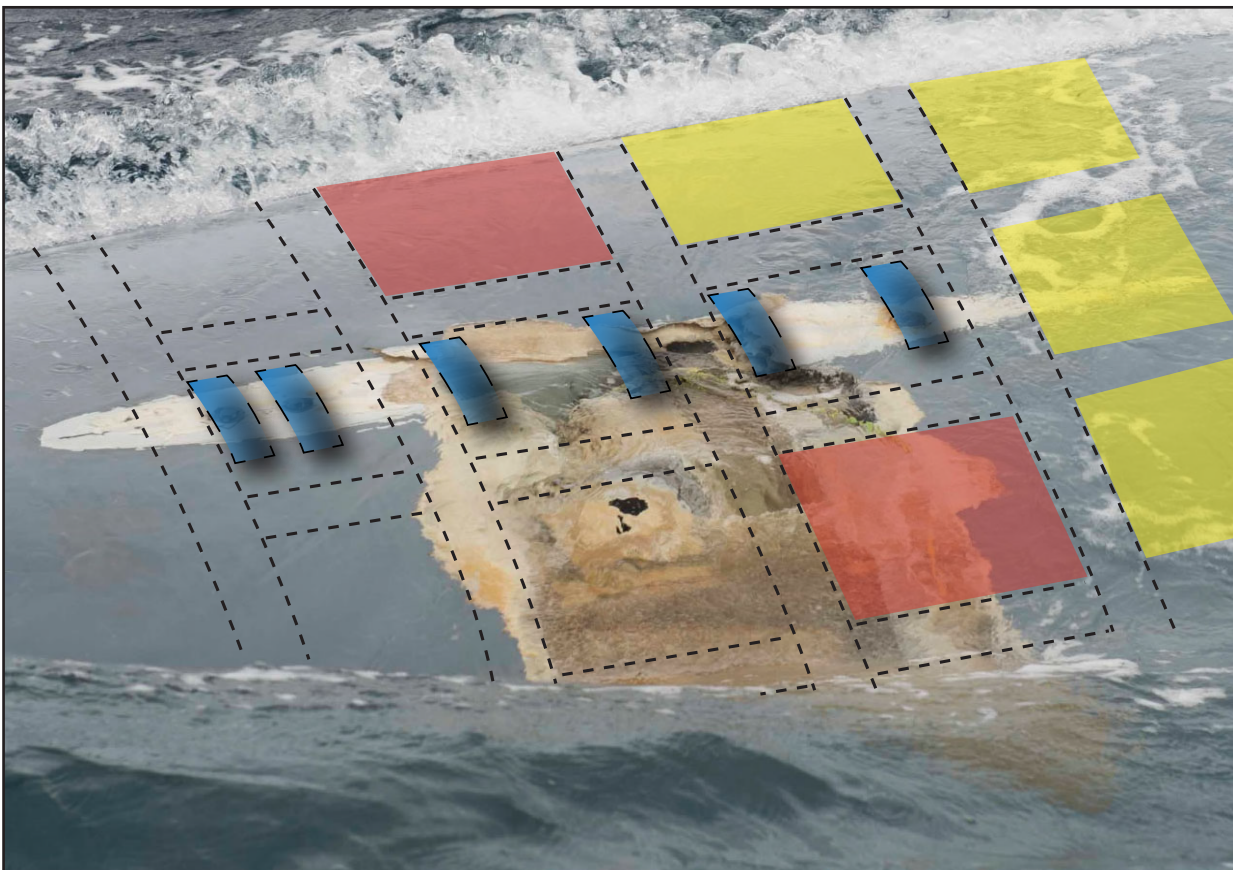
'Remove floor boards and pipe work in way of damaged areas. Cut flanges off six bays, grind back hull, laminate and sides of structural floors. Bond structural floor to hull with GRP, lightly rub down and apply wax gel. Drill off limber holes, refit pipes and floors. Clean vessel. Lift plate washers and re bed.'

The repair invoice also indicates that the repair was not carried out in accordance with Beneteau's recommended method contained in the advice to its after sales and dealer network. Of the repairers visited by MAIB inspectors, there was divided opinion as to the appropriate repair method and, again, there is currently no industry-wide guidance on this matter.

Figure 19: Figure 18 superimposed with the approximate position of the matrix frames and location of the bays probably (red) and possibly (yellow) repaired in 2007
