27233 Cranford Avenue  
Dearborn Heights, Michigan 48127  
July 23, 1967

Mr. Carroll Shelby  
Shelby American, Inc.  
6501 W. Imperial Highway  
Los Angeles, California 90009

I am a Mechanical Engineer and I am employed by the Ford Motor Co. (Design Analysis Group, Heavy Truck). Last January I became the proud owner of a G. T. 500 Shelby Mustang. It's difficult not to be proud after receiving so many compliments on my good looking ("tough", "bad", "cool", "mean", etc.) automobile from people of all age groups. I believe there may be an accident if people keep tailgating and gazing at my G.T. while my vehicle and their vehicle are both in motion.

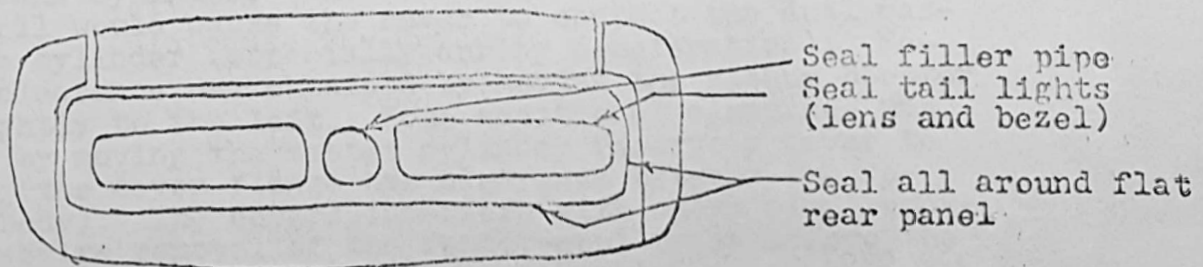
Safety Hazard. Exhaust fumes enter the car via the tail light openings between the flat tail light panel and original Mustang (concave) rear panel. This occurs primarily when the pressure is decreased inside the car due to a window being open. Low pressure due to the spoiler brings the exhaust fumes into the car. I solved the problem by a complete sealing job (after removing the rear bumper).

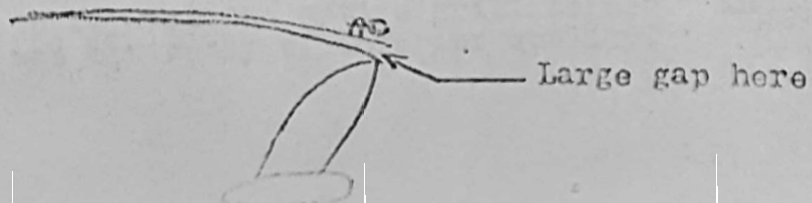
A. Fiberglass hood doesn't fit properly.
