Trail Maintenance Report for the Western States Trail One Locality at a Step-Down Rock Bench North of Kaput Springs in El Dorado Canyon

American River Ranger District, Tahoe National Forest

between Deadwood and Michigan Bluff, Placer County, California

May 17, 2013

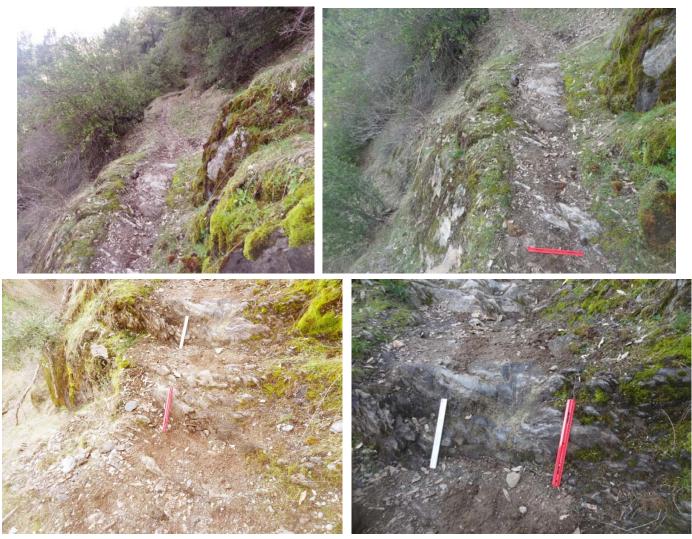
Slippery Rock Surfaces, Steep Step-Down, Drop-off Cliff on Downslope

This set of four photographs (taken March 2, 2013 during a trail reconnaissance) showcases the safety hazard at the step-down rock-bench. One-foot ruler for scale. If a horse were to lose traction here on a steep step-down (= steel horseshoes on smooth metamorphic rock), the horse could collapse and buckle both front feet, with lacerations and severe injuries to the front knees. The drop-off cliff at left is about 70 degrees for the first 30 feet, then the over-all slope angle is about 47 degrees.

These photographs are different views of the same location. Hard metamorphic rock (Paleozoic slate) with vertical foliation is exposed on the tread-surface. One-foot rulers are for scale. The softer rock in the foreground contrasts with the harder rock above, so there is a differential erosion situation.

Motorcycles trying to surmount the steep smooth knob have gunned their rear knobby tires here, which causes mechanical abrasion in the softer rock below.

Horses headed steeply downhill need to lunge forward here, so there is "impact deflation" of the trail-bed from the front hooves. Over many decades of no trail maintenance, a bowl is formed on the trail-bed.
