DISCOVERY OF LEACKY DECK / BULWARKS MOUNTED FITTINGS

by Matthew A. Davidson on S/V Wildflower '83 Passport 40

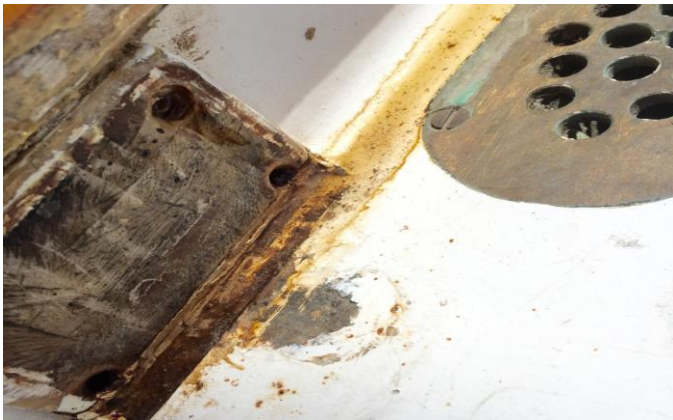
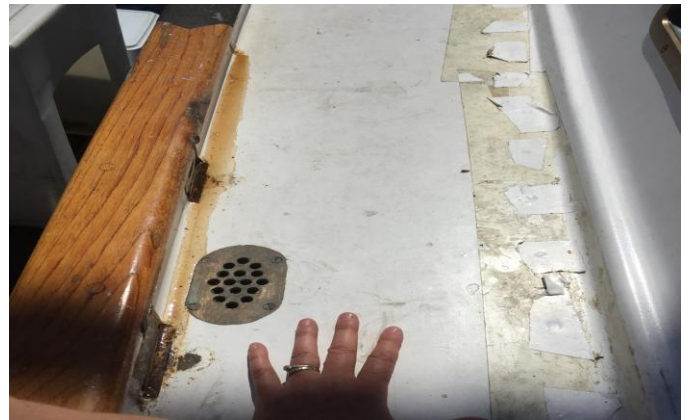
Below are images of current leaky Stanchion mounts on our bulwarks.

After removing the lifeline stanchion bases from the bulwarks... I found two leaky ones. The bedding had obviously failed... especially at the ones next to the port deck drain. Fortunately... all of the bolts came out very easily as who-ever did this last used dolphinite on the bolts with 3M 4000 on the metal face. Actually not a bad combination as the threads did not bind or gall.

Might want to check your Chocks for good bedding seal as well as I'm pretty sure between the Stanchion base, chock and cap rail bedding... these are largely the cause of the tea-staining we all combat. Going to try and clean up the edge of the bulwark/cap rail joint and put a clean bead of Sikaflex 295 down this edge to try and seal from outside weathering. For now... letting it all dry out.
