Report on the investigation of
the loss of the yacht
Cheeki Rafiki
and its four crew
in the Atlantic Ocean,
approximately 720 miles east-south-east of
Nova Scotia, Canada
on 16 May 2014

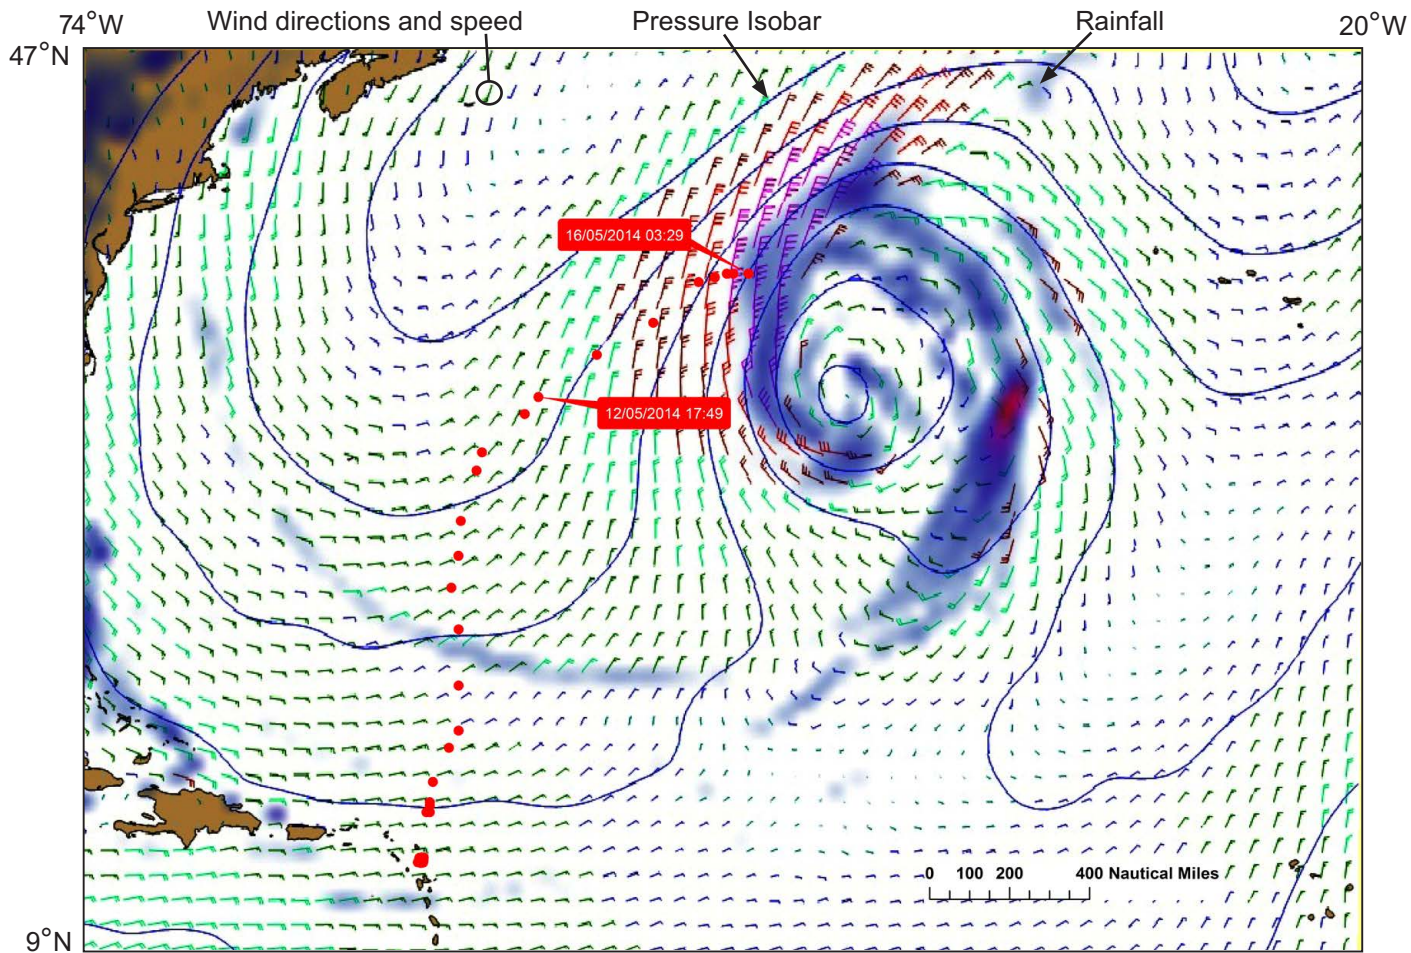
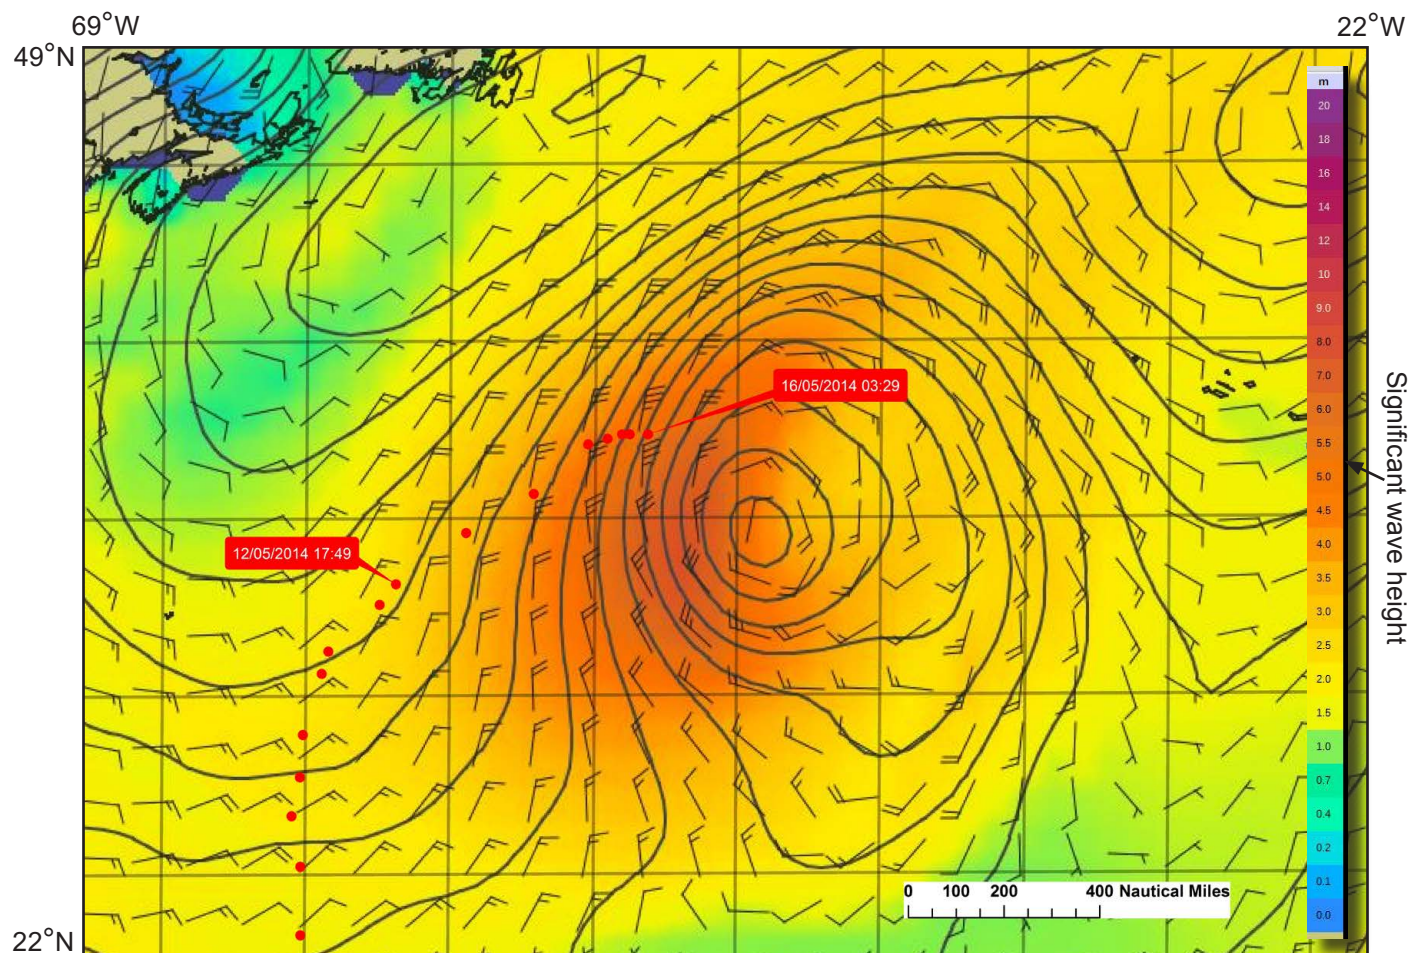
Figure 4: Ugrib forecast conditions for 0300 16 May 2014, as predicted at 0600 on 12 May 2014

Figure 5: zyGrib forecast conditions for 0300 16 May 2014, as predicted on 12 May 2014

In his email of Saturday 10 May the skipper reported having to use the engine the previous night due to light winds, and when the principal/director replied to that email on Monday 12 May he advised the skipper to '*perhaps steer NE*'. The principal/director's email mentioned that there would be lightish winds until Wednesday, but did not warn of the worsening conditions thereafter (see **Figures 4** and **5**) that were predicted in the Ugrib 12 May 0600 forecast.

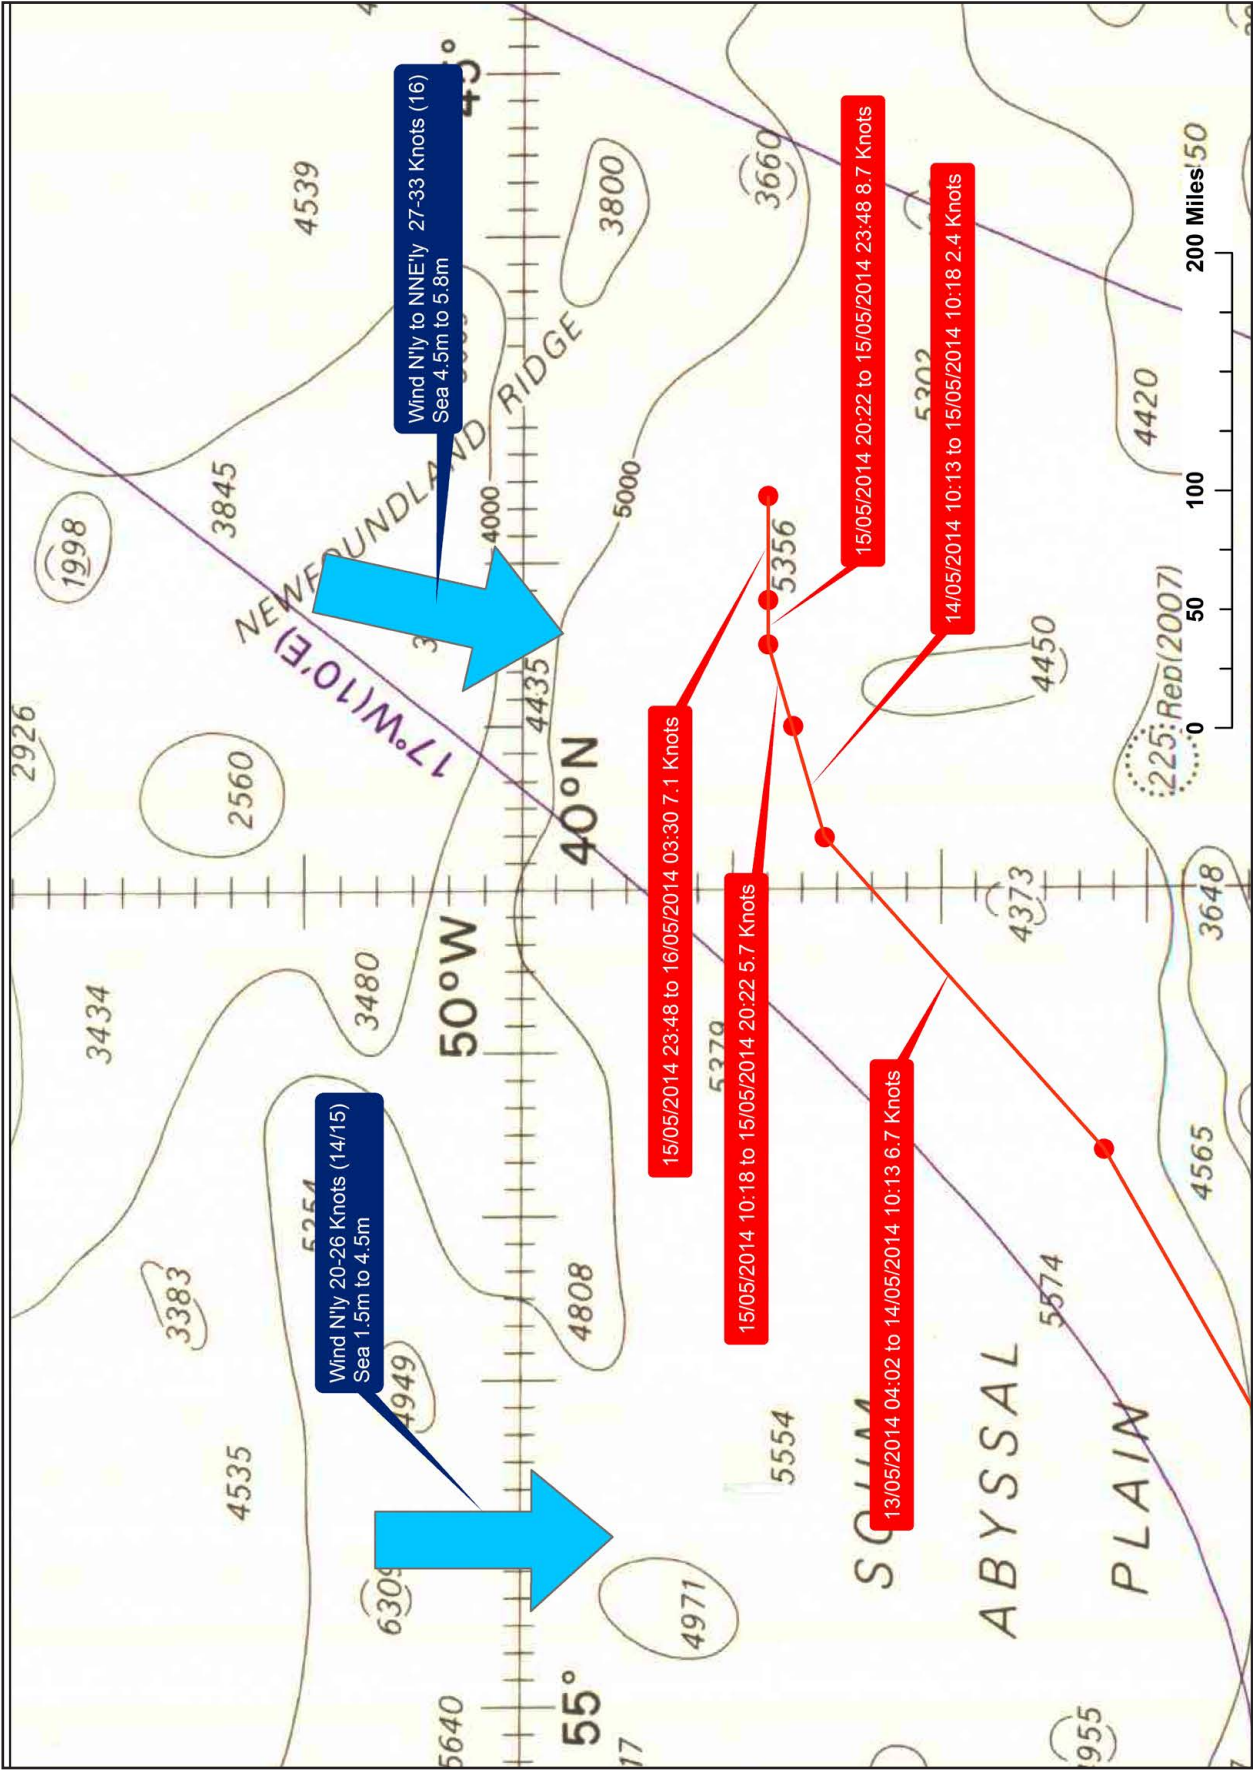
Without the benefit of the principal/director's advice, it is possible that the skipper had neither identified nor considered that the source of water ingress was in the keel area. Consequently, it is probable that he had neither recognised the increasing risk of the keel becoming detached nor the danger of continuing on the same approximate course without reducing speed (**Figure 20**), producing high lateral keel load; a point not included in the principal/director's advice.

Figure 20: Cheeki Rafiki's indicative courses and speeds made good obtained from its Iridium satellite telephone recorded positional data between 14 May and 16 May 2014
