With Gas shielded Flux Cored Wires:

GAS SHIELDED FLUX CORED. WORM TRACKS & WELD POROSITY:

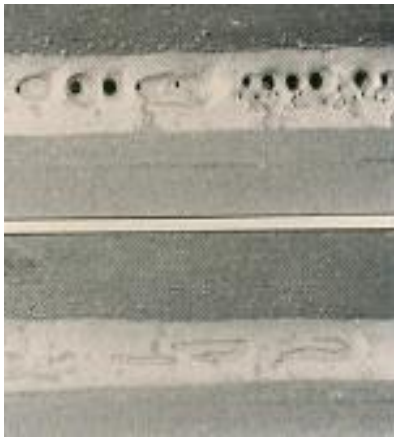
Weld porosity: As indicated in the picture, a cavities or discontinuities have formed in the molten weld. The porosity can be trapped inside the weld or evident at the weld surface.

Weld porosity is typically round in shape, but can also be elongated. Porosity is caused by the absorption of oxygen, nitrogen and hydrogen into the molten weld pool. The gases are then released during weld solidification. As the gases try to rise to the weld surface some gas pores will become trapped in the weld metal, some pores pass into the weld slag, while other pores will combine on the weld surface producing **worm tracks**.

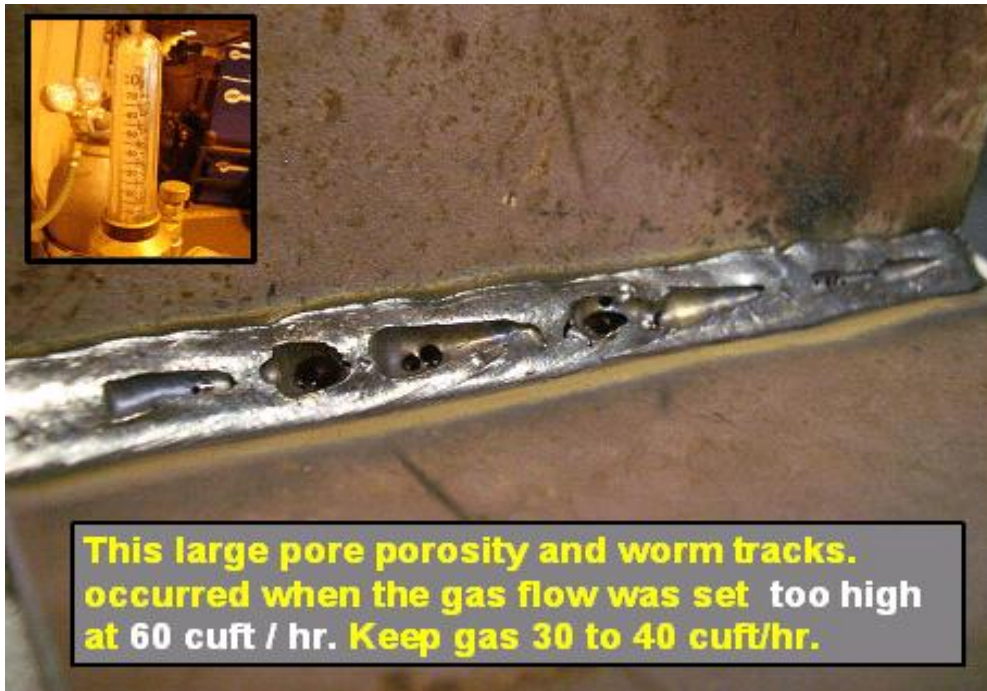
E71T-1. Flux cored weld porosity from and Excess Gas Flow.

LARGE PORE WELD POROSITY. If weld surface is clean and does not look oxidized, large pore MIG / FCAW porosity is often a result of "excessive gas flow".

Excessive gas flow causes weld surface turbulence. This porosity can result with gas flow greater than 45 cuft/hr. Optimum MIG and flux cored gas flow for carbon steels is 25 to 35 cuft / hr. The shielding gas flow should be measured as it exits the gun nozzle.

If the weld surface is dirty (oxidized) the cause of larger pore porosity is often a result of insufficient gas flow, less than 20 cuft /hr.

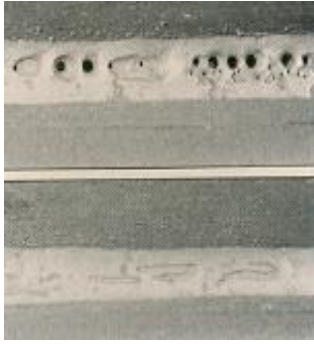
CLUSTER WELD POROSITY. A localized group of small gas pores with random distribution. Causes.

- [a] Arc blow,
- [b] if surface oxidized, insufficient gas,
- [c] material or weld wire contamination,
- [d] (low) weld parameters,
- [e] welds too small or too wide and too thin.

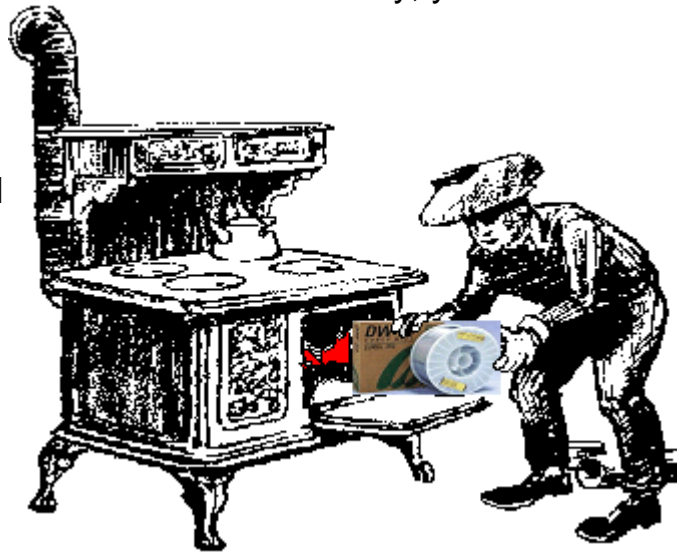
PIPING, WORM HOLES OR SOME CALL IT WAGON TRACKS. As seen in bottom picture the "wagon tracks" are typically found in the center of the gas shielded weld, parallel to weld axis, this is the last area for weld solidification so the porosity congregates as one.

The worm holes or wagon tracks are elongated gas pores producing a herring bone appearance on a radiograph. Worm hole porosity is common in gas shielded flux cored welds when the electrodes have **too much moisture** in the wire flux or the weld solidifies too rapidly.

If you purchase the flux core wire from a third world country, you are almost guaranteed severe weld porosity issues. The cheaper the flux cored wire, the greater the potential for wagon tracks. If the flux cored products are not stored in a dry atmosphere look out for porosity and wagon tracks. To reduce wagon tracks,

[a] extend the wire stick out as this preheats the weld wire but remember it also lowers the weld current,

[b] storing the wires in a dry environment reduces this potential,

[c] slow weld speeds,

[d] make welds larger,

[e] avoid weaves,

[f] increase current and decrease voltage.
