Resonant Instruments LLC		
Title The Nixie Wristwatch		
Size B	Document Number (Doc)	Rev A
Date: Saturday October 05 2001	Sheet 1	of 1

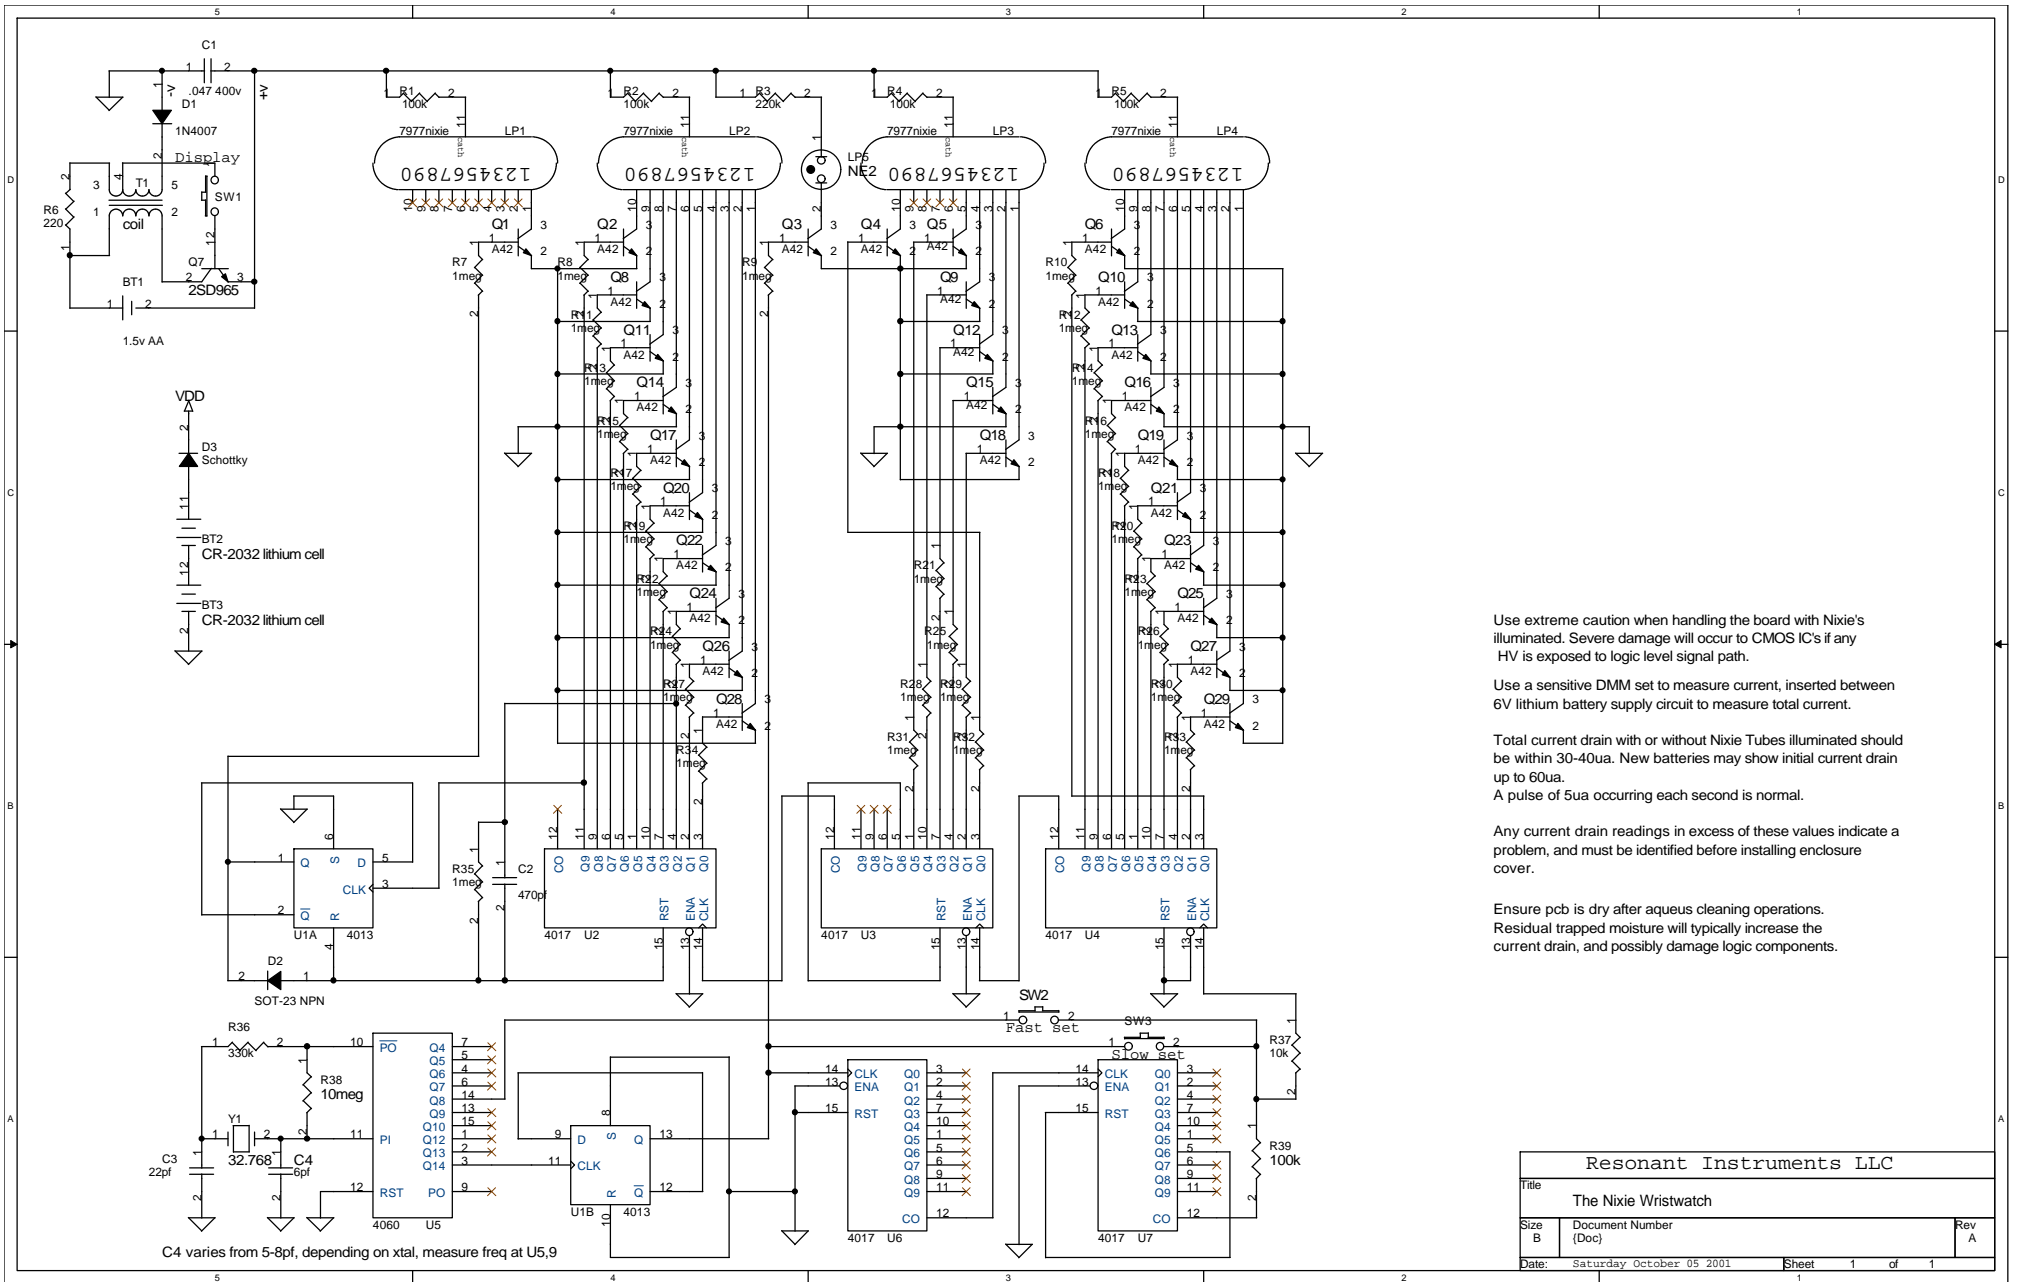
Use extreme caution when handling the board with Nixie's illuminated. Severe damage will occur to CMOS IC's if any HV is exposed to logic level signal path.

Use a sensitive DMM set to measure current, inserted between 6V lithium battery supply circuit to measure total current.

Total current drain with or without Nixie Tubes illuminated should be within 30-40uA. New batteries may show initial current drain up to 60uA. A pulse of 5uA occurring each second is normal.

Any current drain readings in excess of these values indicate a problem, and must be identified before installing enclosure cover.

Ensure pcb is dry after aqueous cleaning operations. Residual trapped moisture will typically increase the current drain, and possibly damage logic components.
