**Project Information**

<b>Project Name:</b>	RSIC Stage 2 von Haast Building	<b>Date:</b>	27 August 2017
<b>Project Number:</b>	DC-1871	<b>Client:</b>	University of Canterbury
<b>Site Address:</b>	Forestry Rd	<b>Supervisor:</b>	Keegan Hewlett/ Gary Butterfield

**Summary of works**
**L3 North Enclosure 3&4**

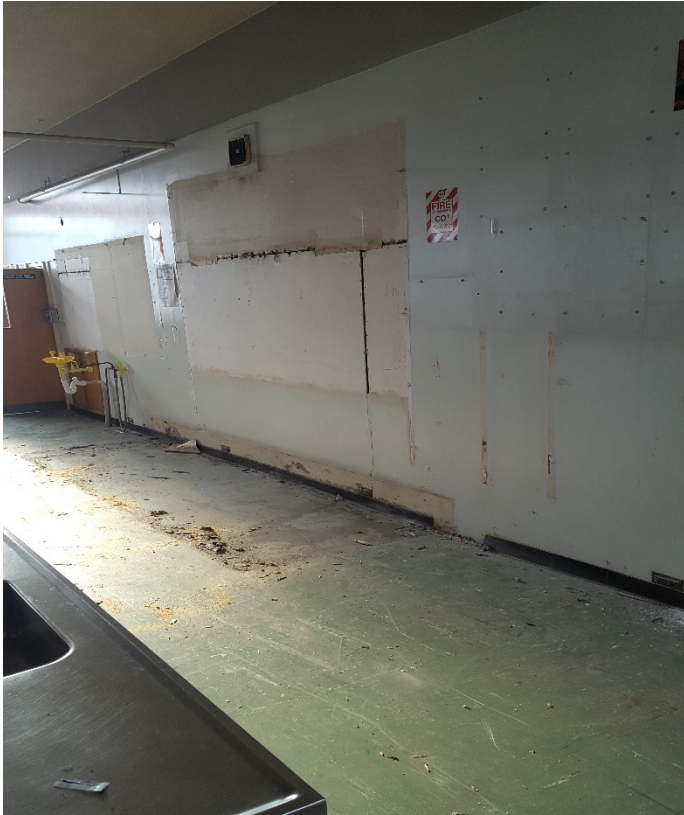
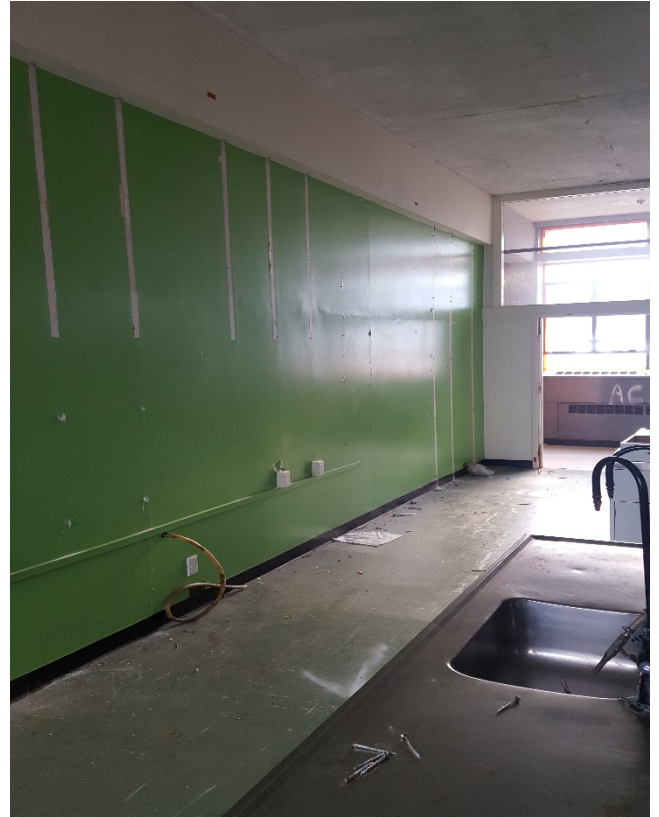
Level 1 and 2 strip out, before setting up enclosures, sealed areas with ACD contamination
